A message from our CEO & Technical Director

Welcome to the latest edition of Corrocoat News, the first in 2022. As we look forward and find ourselves in the New Year with exciting developments, plans and opportunities on the horizon, I'd also like to reflect on last year. I take this opportunity to applaud the team at our Leeds Head Office and also all of our International Partners for their ongoing commitment to the business and continuity of service, throughout what has continued to be challenging, uncertain and unprecedented times. It is this very passion, drive and dedication, which underpins the heart and soul of the company and what we do.

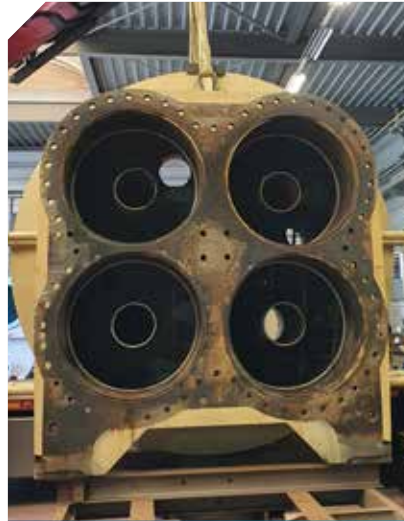
Following 8 years in service, the epoxy coating in the internal cooling water area became detached, causing a leakage in the cooling water area of the air section. Unbeknownst to the team, the housing unit weighed an enormous 13 ton and upon arrival to the workshop presented a logistical challenge getting the unit offloaded and ready to begin the repair work. The overhead crane onsite was only capable of lifting 6 ton, so the team arranged for a mobile crane to move the housing unit. With a tight schedule of just two weeks given to complete the work, the coating team didn't disappoint, working around the clock to ensure that the job was completed to the client's satisfaction.

Cooling water area before protective coating

The team sandblasted the housing internal and external before applying the Corroglass 600 series internally, with the externals being coated with Plasmest ZF and a top coat of AP1.

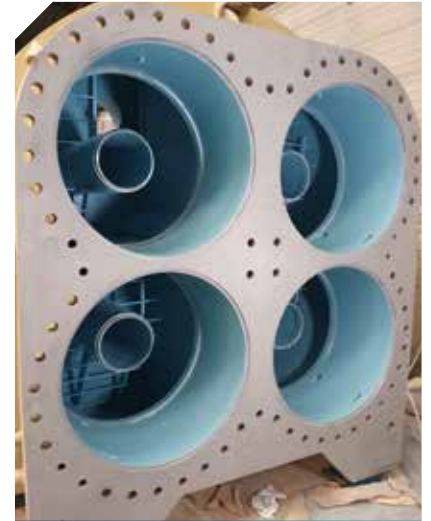
Cooling water area following protective coating

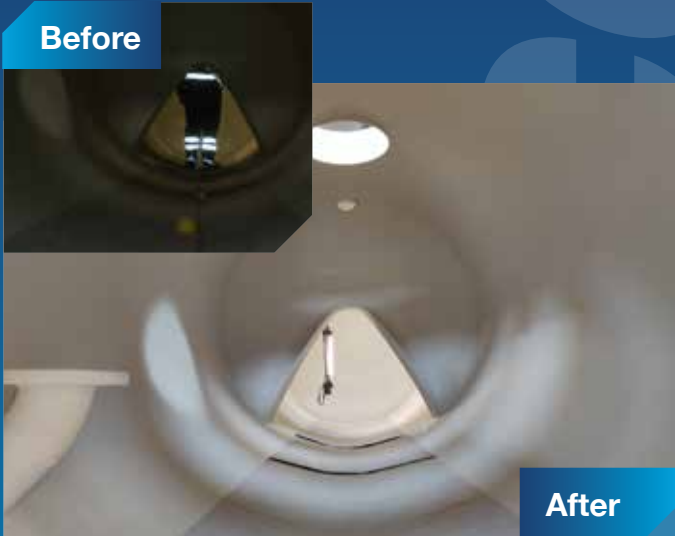
Before

The tank was 7.5m long with a diameter of 1.91m. Access was provided through two off 600mm tank top manways and another at the bottom of the rear dish. The tank would be collecting acidic liquids, with the possibility of weak solvents, all at ambient temperatures. With this in mind, Polyglass VEF was the coating system selected for the job. Polyglass VEF is specifically designed to offer the corrosion in aggressive chemical environments and has a proven track record with road tankers

The first coat of Polyglass VEF was applied by airless spray to a minimum WFT (Wet Film Thickness) of 600 microns. As part of a comprehensive corrosion protection coating system, fibreglass woven matting was applied to the interface areas of the tank and the bottom 1/3rd of the shell below the manway access points, i.e. baffle joints and manway neck joints. These reinforced layers improved the tensile properties of the coating and cracking resistance due to movement.

Following a second coat of Polyglass VEF to a specified minimum DFT of 1200 microns, thickness checks, spark testing and a 100% visual inspection was completed. A final topcoat of Polyglass VE Veilcoat was then applied. On completion of the application, the coating was post cured at 60–80°C for 8 hours to ensure the full cure offered resistance required against the waste streams being collected.
