CORROCOAT news

July 2023

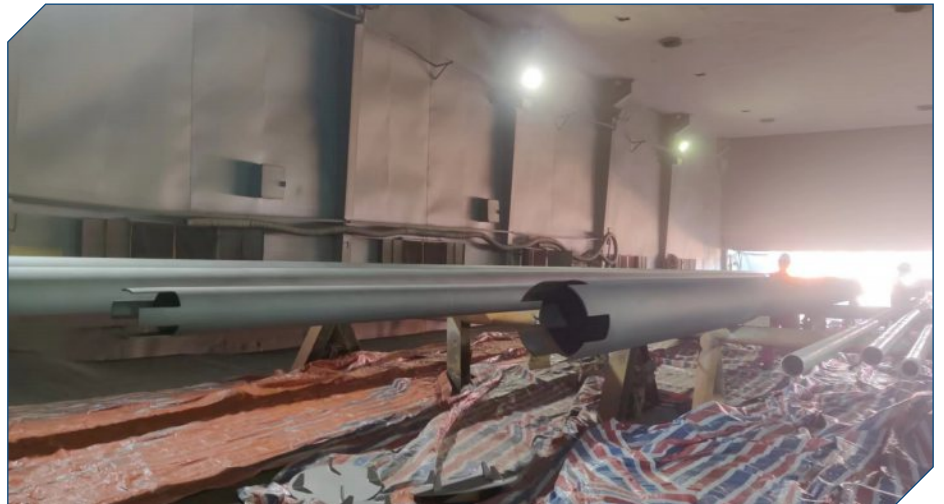
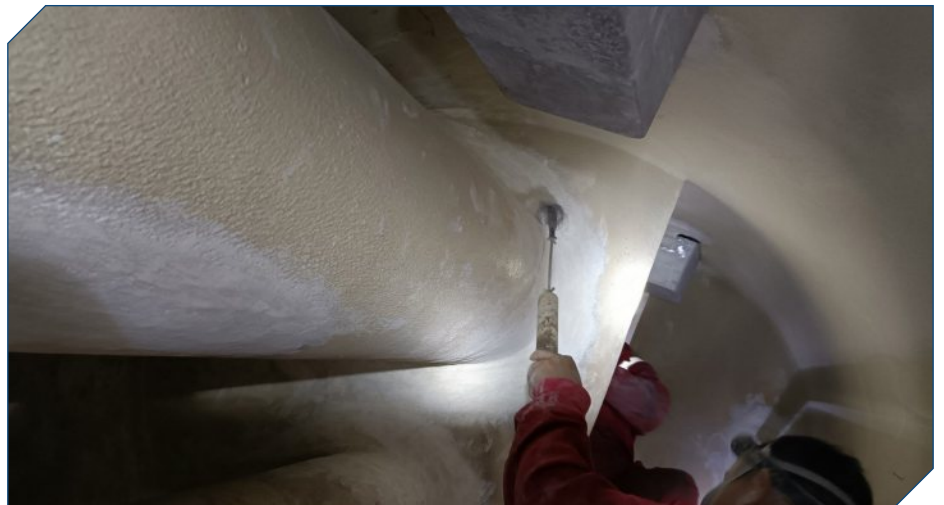
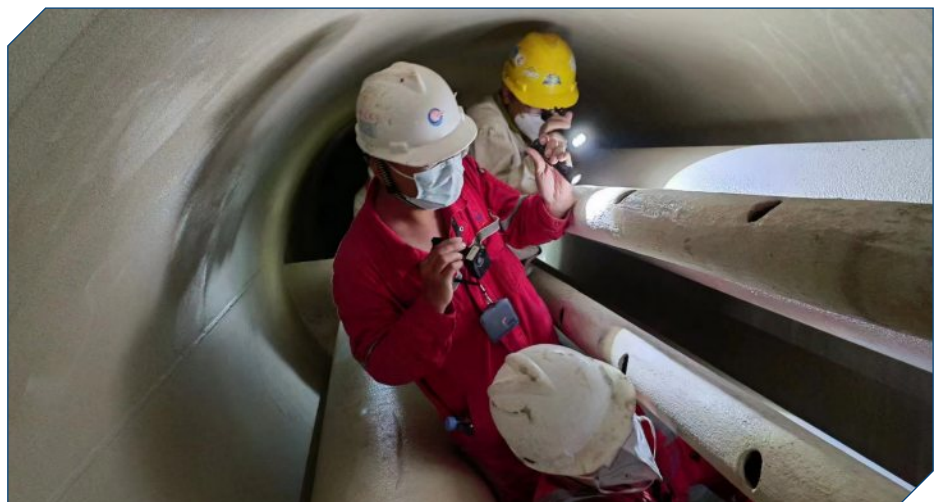
Leakage Prevention and Protection for New Open Drain Caisson

The client decided protecting the 52-metre long caisson and extending its service life from the start, with Corrocoat, was the best and most viable option. As part of the project the client commissioned the team to also protect the internals of an attachment pipeline, which was to be inserted in the caisson.

The team completed the project on-site and selected Polyglass VEF to line the caisson internals, via spray application. The pipe internals were also coated with Polyglass VEF, after first being split in to 2 sections. Once cured, the client welded the pipe sections back together, and a total of 10 pipes were inserted in to the caisson.

When in position, the team re-prepared the field fit weld area and coated over the weld joints with Polyglass VEF to complete the corrosion protection. The conditions in the caisson to complete the final stages of the project were very challenging, with a restrictive workspace as a result of the diameter of the caisson and the inserted pipes.

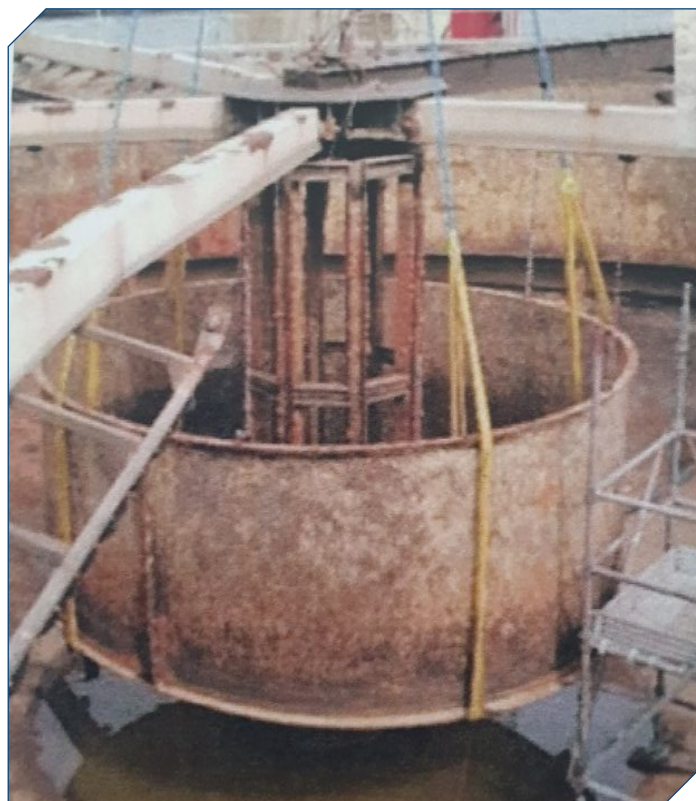
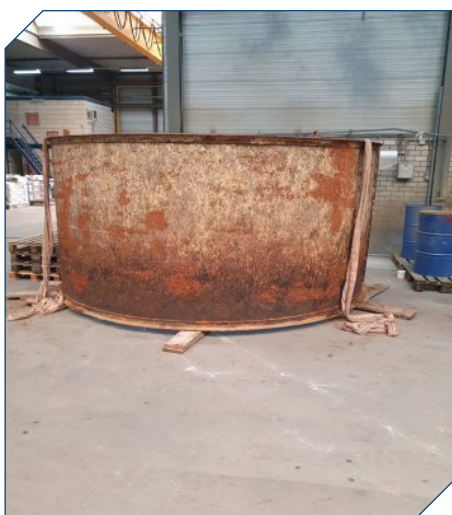
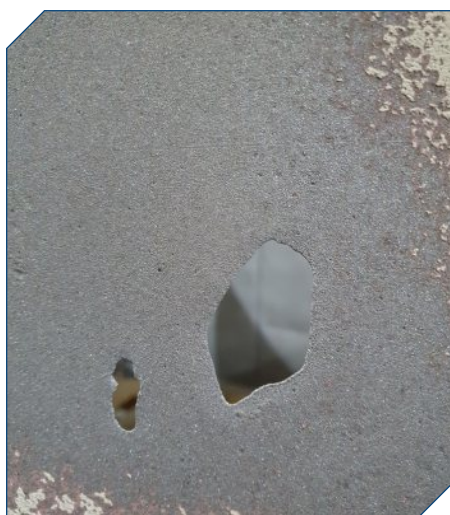
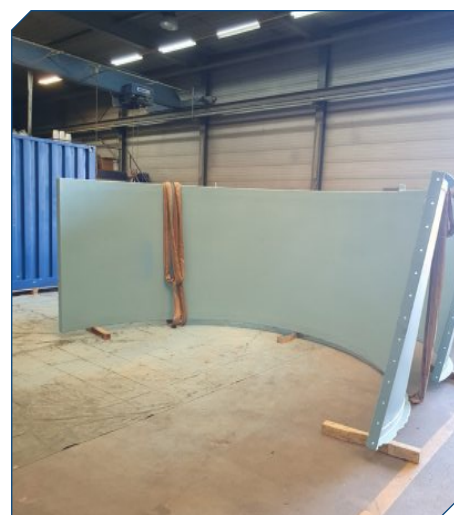
Repair for Secondary Settling Tank Suffering Severe Corrosion

Our partners at Corrocoat Benelux, recently worked on a project to repair a secondary settling tank, which was suffering from severe corrosion. The tank, which had its last inspection over 10 years go, had been in service at a petrochemical plant, and was in much need of repair, having been subjected to waste sludge.

Following an on-site inspection, during an outage, it was discovered that the 2 outer shells, which were 2.4 metres high, with a diameter spanning 4.5 metres, were severely corroded.

Before transportation to the Corrocoat workshop, the skirt of the tank was dismantled by the Corrocoat team, to allow for easier transportation and repair. Upon arrival, the shells were abrasive blasted, before Corroglass 632 was applied to prime the substrate. Fibre glass matting was then applied to the damaged areas, ahead of 2 layers of Polyglass VEF.

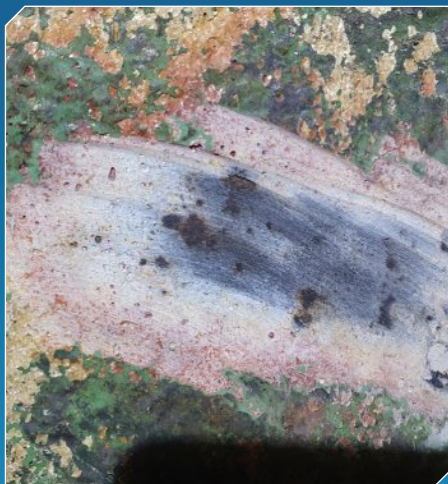
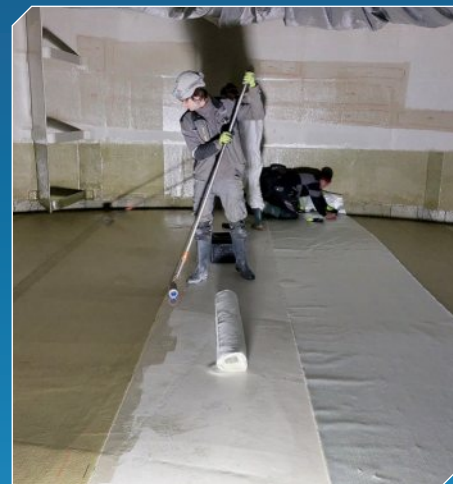
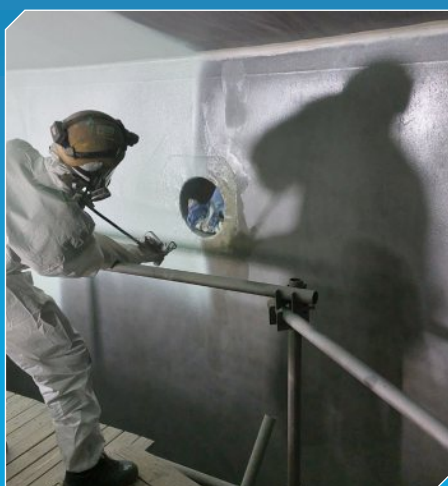
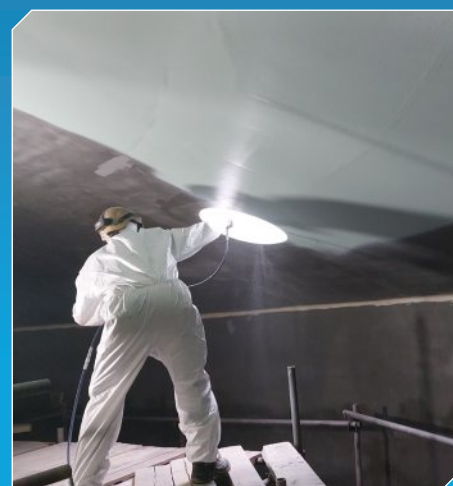
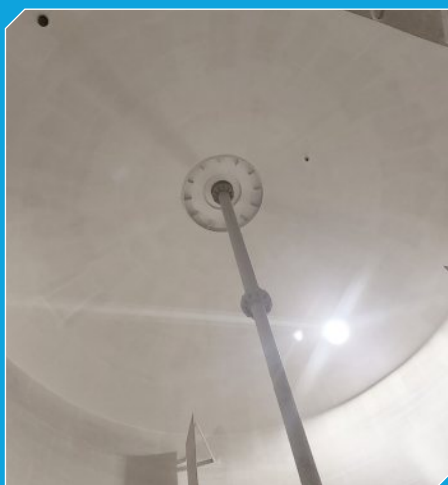
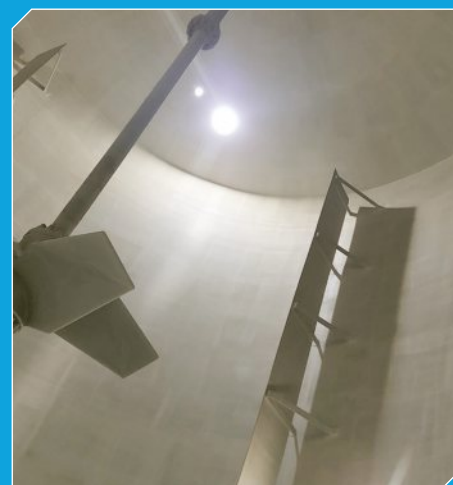
Renovation of Corrosion Protection of Chemical Storage Tank Internals

The 960m² tank (12.5m diameter x 15m height), stored limestone slurry. The previously applied coating was extremely porous and had been poorly applied, which resulted in pitting on the carbon steel substrate. The client turned to Corrotech to provide a coating which would offer long term corrosion protection.

Undergoing the project in Winter, temperature regulating and dehumidifying equipment was required for blasting, and throughout all of the coating application. The team spent 72 days completing the work carrying out the following:

- Removing sediments and the previous coating
- Decontaminating soluble salts from the surface
- Preparing the surface to ISO 8501-1 with cleanliness Sa 2½ near to Sa 3
- Applying Polyglass PPA (as a primer) via airless spray application
- Applying Corrofill VE to fill in the pitted areas
- Applying lamination layer L600 + Fiberglass Cloth 600 g/m² to the tank floor and 1m of the shell wall.
- Applying Polyglass VEF as a corrosion barrier
- Quality assurance as per designed Inspection and Test Plan (DFT Test, Holiday Detection Test, Pull-off Test)

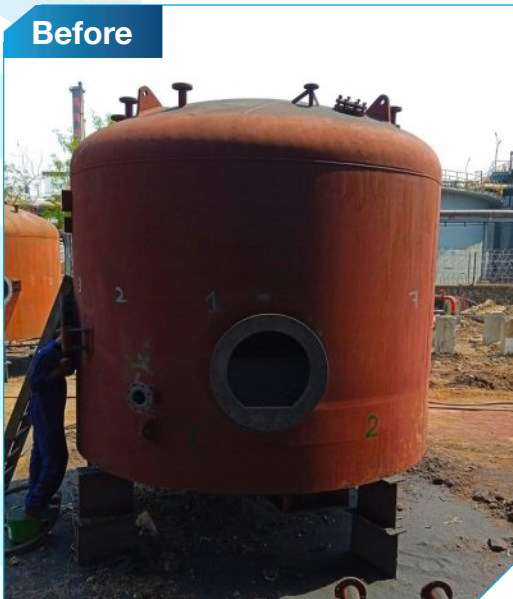
Before

In chemical manufacturing processes, Agitated Nutsche Filters (ANF) are essential equipment for the separation and filtration of solid and liquid components. However, the corrosive nature of the chemical process liquids can pose a challenge to the ANFs, leading to degradation and equipment failure.

A renowned chemical manufacturing company in Maharashtra, India, approached Kirloskar Corrocoat Private Ltd, our partners in India, to provide long term protection against chemical attack and erosion for two ANFs. Each one measured 3m in diameter by 2.25m, and included accompanying components; the vessels, agitators, mesh plates and bottoms.

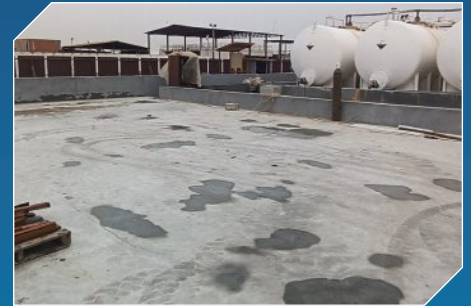
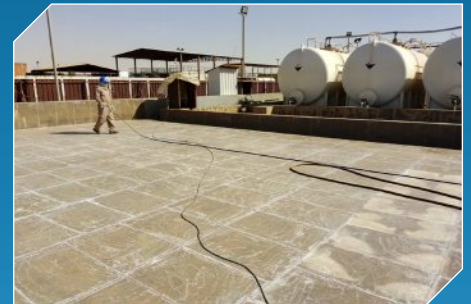
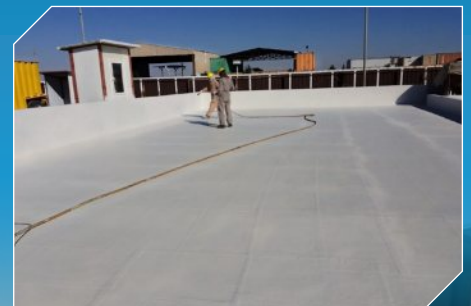
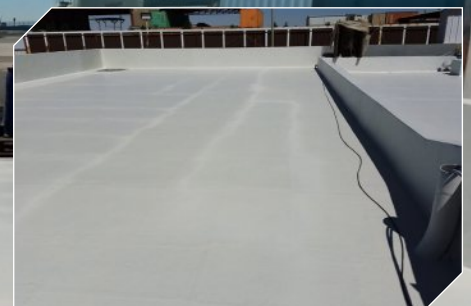
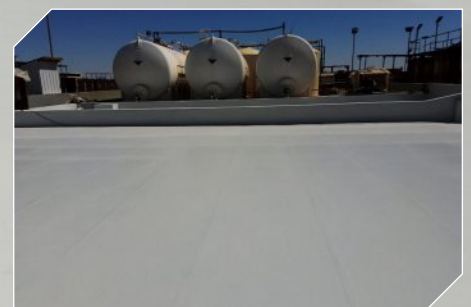
Long-term Cost-effective Protection for 500m² Concrete Floor

Over the years the concrete floor had continued to suffer corrosion as a result of raw hydrochloric acid spills. To try and rectify the issue, the client would constantly re-concrete the floor, which proved both ineffective and extremely costly.

A team of 4 applicators completed the project in 24 days; preparing and coating a concrete floor which had been laid 28 days prior to work commencing. Initially, the surface was abrasive blasted to remove surface laitance or weak frangible material. Following the removal of dust and debris and thoroughly vacuum cleaning, the prepared concrete was then primed with Polyglass PPA, which was used as a penetrating primer and to strengthen the immediate top layer.

The team then applied a Corrocoat laminating system, prior to the application of Polyglass Standard, to 1500 microns.

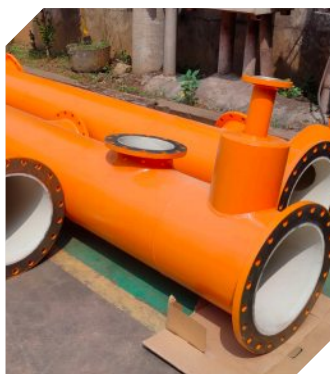
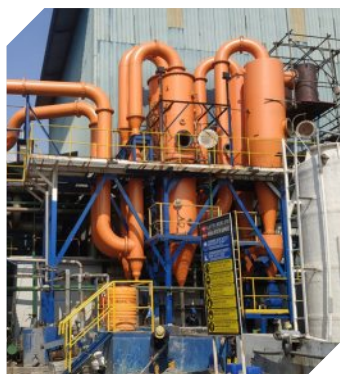
CO² Pipe, Scrubber, and Separator Internal Lining

In 2012 the maintenance team at a sugar mill in Indonesia were fighting a losing battle against corrosion on the welding joints of their CO² pipeline. The purpose of the CO² gas at the sugar mill was for carbonation, ultimately improving the quality of the sugar.

At that time, the plant was using SS304 & SS316L stainless material for their pipework. But, after just six months in service, the pipework was suffering leaks on the welding joints areas.

Over 220m of pipework was transported to the Corrocoat workshop (in Indonesia), where the team were tasked with providing a long-term solution. Polyglass was the recommended coating system.

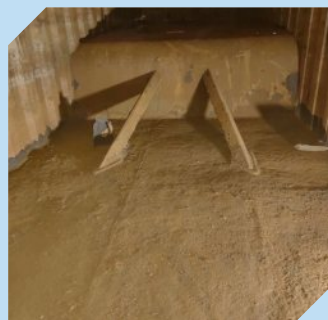
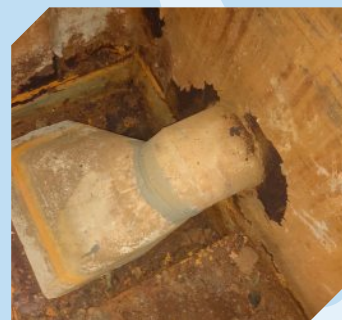
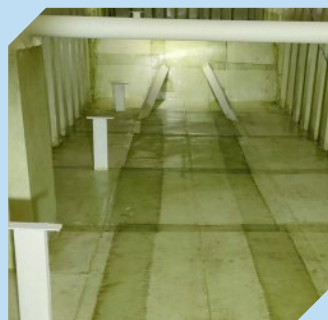
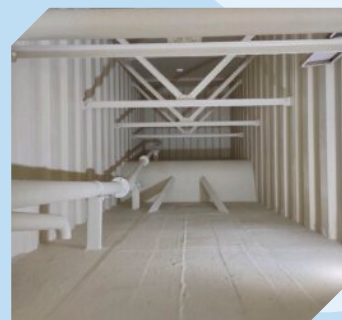
Internal Refurbishment of Frac Tank

A mobile frac tank storing Brine, KCL (Potassium Chloride) 4%, and solvents recently came to the Corrocoat workshop in Indonesia, with heavy uniform corrosion and pitting on nearly every surface visible.

Created with multiple connection hoses in order to pump fluid from the tank to the rig, the 500 BBL double wall horizontal tanks were primarily designed to store invert and base oil. The tank internals were in very poor condition, with holes in the floor and tank wall. The client attempted to patch up the leaks, but was unable to identify all of the defects, as the majority were hidden under debris and contamination. The corrosion had also consumed most of the floor, and the client had considered discarding the tank and replacing it, as previous attempts to fix, didn't offer a long-term solution.

Corrocoat carried out internal surface preparation via blasting, followed by replacing the entire floor. This was done by installing 5mm carbon steel plates. Blasting was carried out again until Sa2½ metal cleanliness was achieved, with a minimum profile of 50-75 microns. The weld joints and 90° angles were then stripe coated with Polyglass VE.

The next stage saw airless spray application of Polyglass VEF, with a layer of laminate to the floor and 25-50cm up the tank walls. In addition, Corrofill VE was used to smooth out any uneven surfaces.

The inner side of the tank had a final coat of Polyglass VEF and was left to cure ahead of being leak tested with 32,000 litres of water. The test was completed without any issues and the tank is now back in service, at a fraction of the replacement cost.

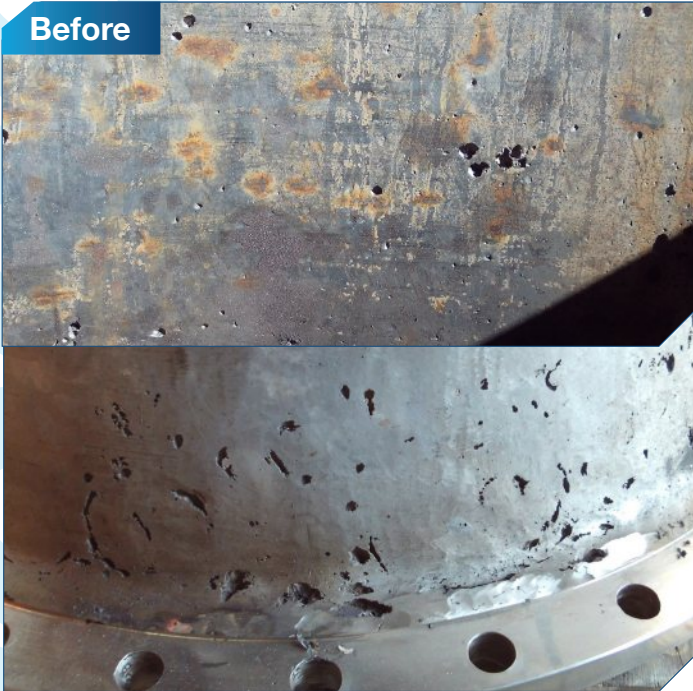
Before

A global leader in fluid engineering, recently sub-contracted Corrocoat UK, to repair and protect a pump stage casing. The casing had suffered chloride pitting as a result of being subject to sea-water for over 2 decades, at a power station.

Following the necessary preparation of the substrate, the deep pits were filled with Corrofill E (a non-shrink filler and repair compound), on the internals and externals, and then smoothed back to suit the original profile. Our glass reinforced laminating resin was then applied to the external, offering additional protection and a water tight finish, ahead of Corroglass 600 series being applied over the top.

Corroglass 600 series was selected as it has excellent performance in immersed environments and exceptional resistance to de-mineralised water. The client was extremely satisfied with the end result, not to mention the significant cost and time saving, when comparing the repair of the existing stage casing, to replacing it.

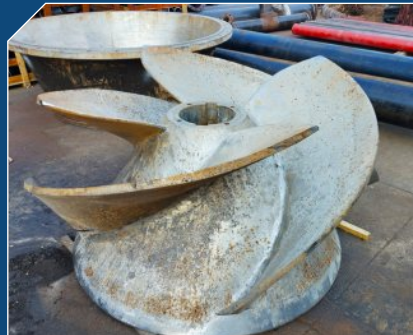
A thermal power plant in Gujarat, India required refurbishment and corrosion protection for four vertical turbine pump impellers. The pumps, which were made of super duplex steel and had no prior protective coating, had been in operation in sea-water for approximately 12 to 15 years.

The impellers had developed cracks and mechanical damage over time, which significantly impacted their performance. To address these issues, the client approached our partners in India, Kirloskar Corrocoat Private Ltd (KCPL). KCPL were to provide a comprehensive solution; repairing and rebuilding the blades, as opposed to replacing with new impellers.

Impeller before

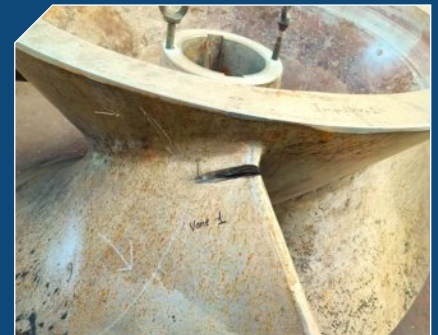
Crack on Impeller

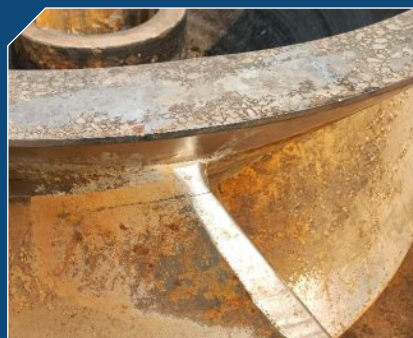
Welding Work

Along with sister company Kirloskar Brother Limited; a global leader in pump systems, KCPL were able to offer a turnkey solution to repair the damage to the impeller vanes, using both cold and hot refurbishment methods, followed by DP (dye penetration) and UT (ultra-sonic testing). Polyglass VEHA was then applied, with an overcoat of Fluiglide.

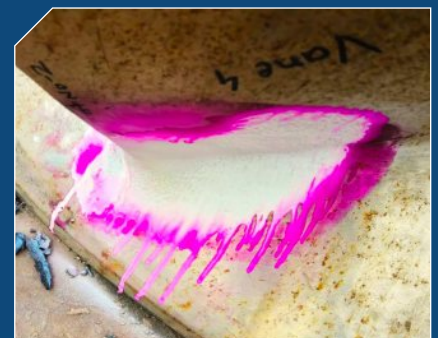
Dye Penetration Test

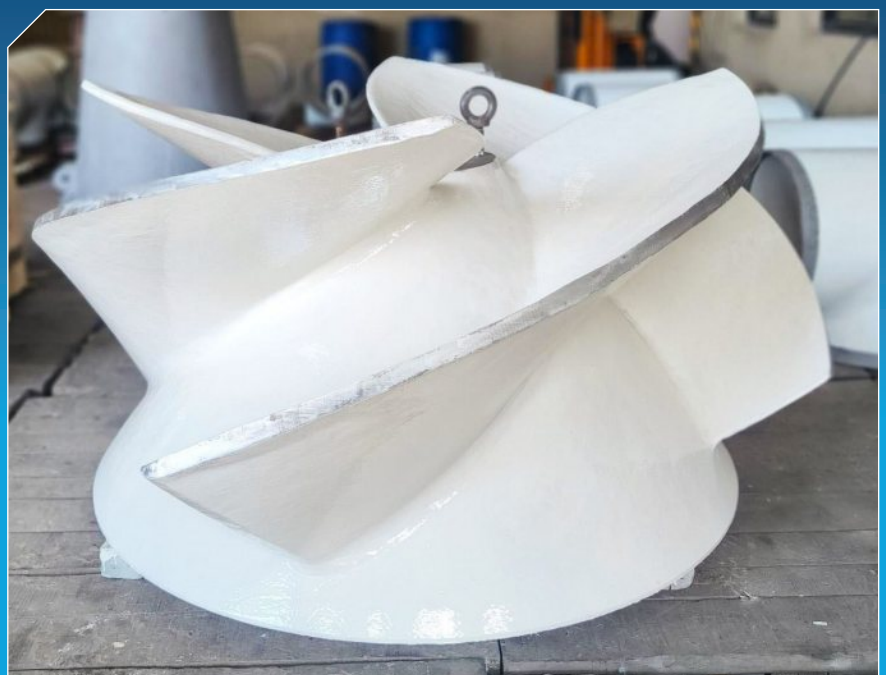
Impeller after

Following the mechanical refurbishment and coating work as per ISO 21940, the team carried out dynamic balancing of the impeller. They also successfully resolved the problem of uneven clearances between the impeller and liner, further optimising the pump's performance and efficiency.
