# **CORROCOAT** news

May 2024

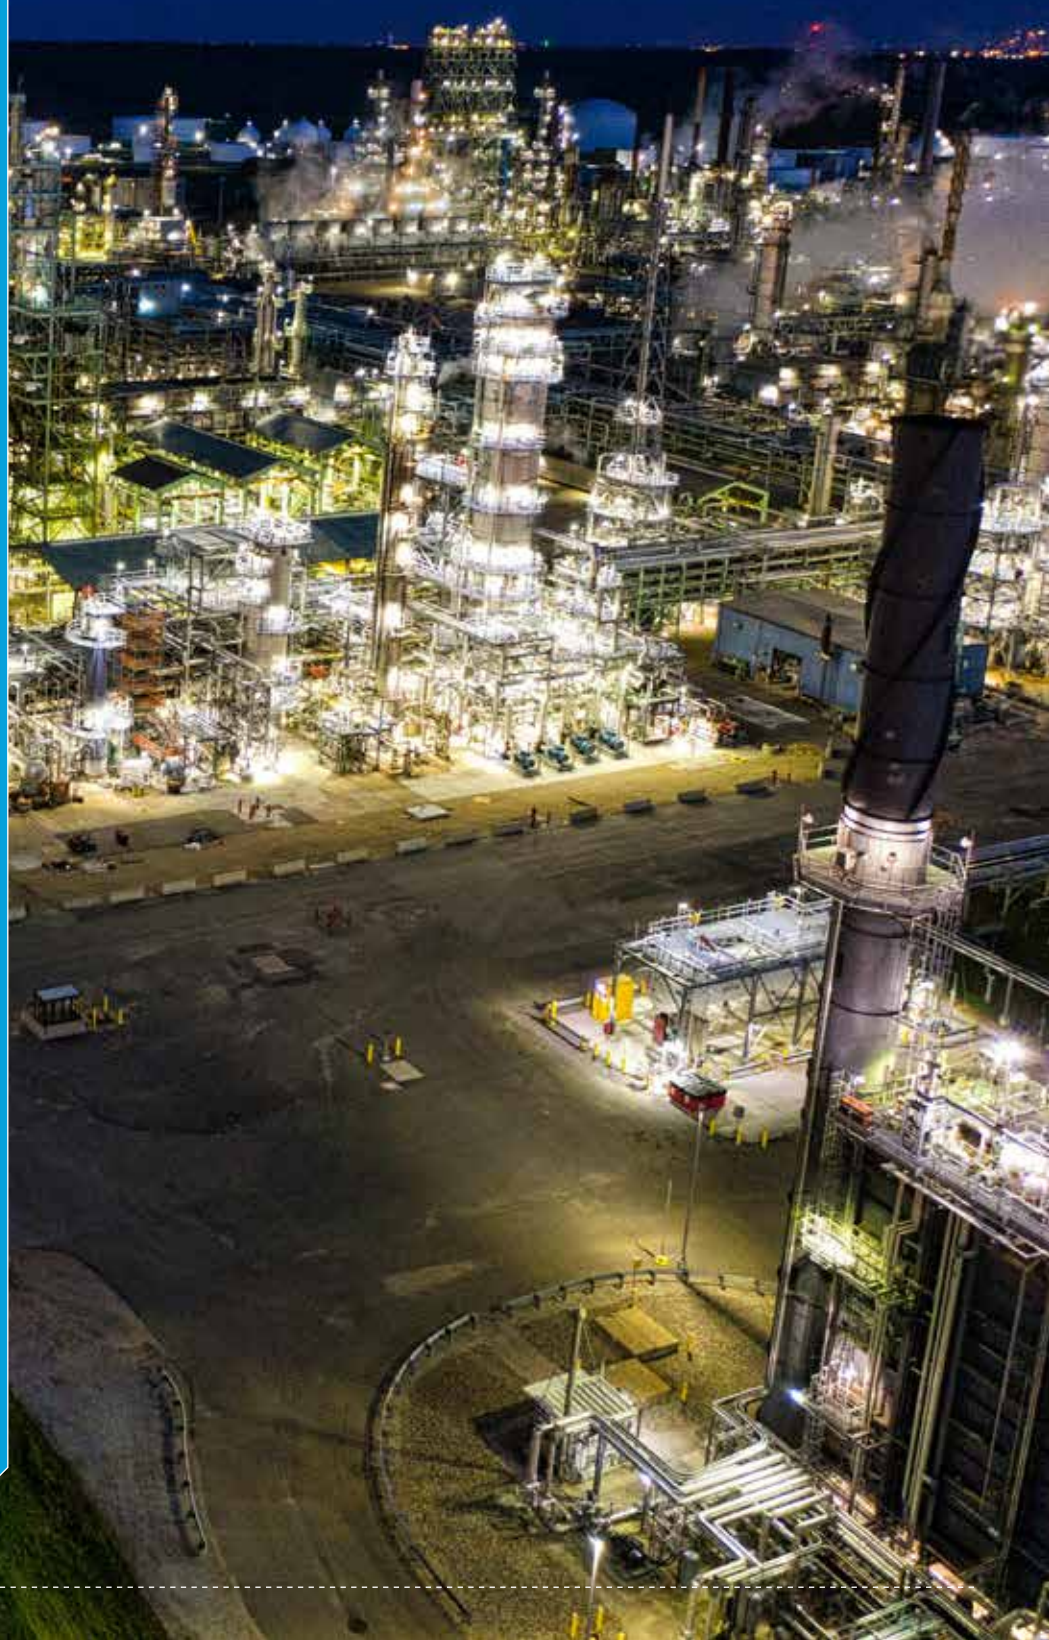
## Reinforcement for Y Pipe

**A client at a petrochemical plant in the Czech Republic required reinforcement of a carbon steel 500mm diameter pipe, spanning 16m<sup>2</sup>. The pipe was part of a refinery tower, transporting nitrogen, and was suffering from corrosion under insulation, which compromised the thickness and integrity of the substrate, in certain areas.**

It took the team 4 days to complete the project in-situ. The first step was to clean the corrosion deposits, this was done via hand tools, before priming with LR600. Four layers of multiaxial fibreglass cloth were then applied to provide strength and reinforcement to the pipe. The complicated shape/'Y' nature of the pipe, posed a challenge in terms of the wrapping of the lamination cloth, which the team effectively navigated. The team also had to carry out the work and take extra precautions with the wrapping aspect, as a result of the nitrogen continuing to run through the pipe, with a surface temperature of 70°C. Polyglass VE was applied by hand, and the work was then tested and assured as per the designed inspection and test plan.

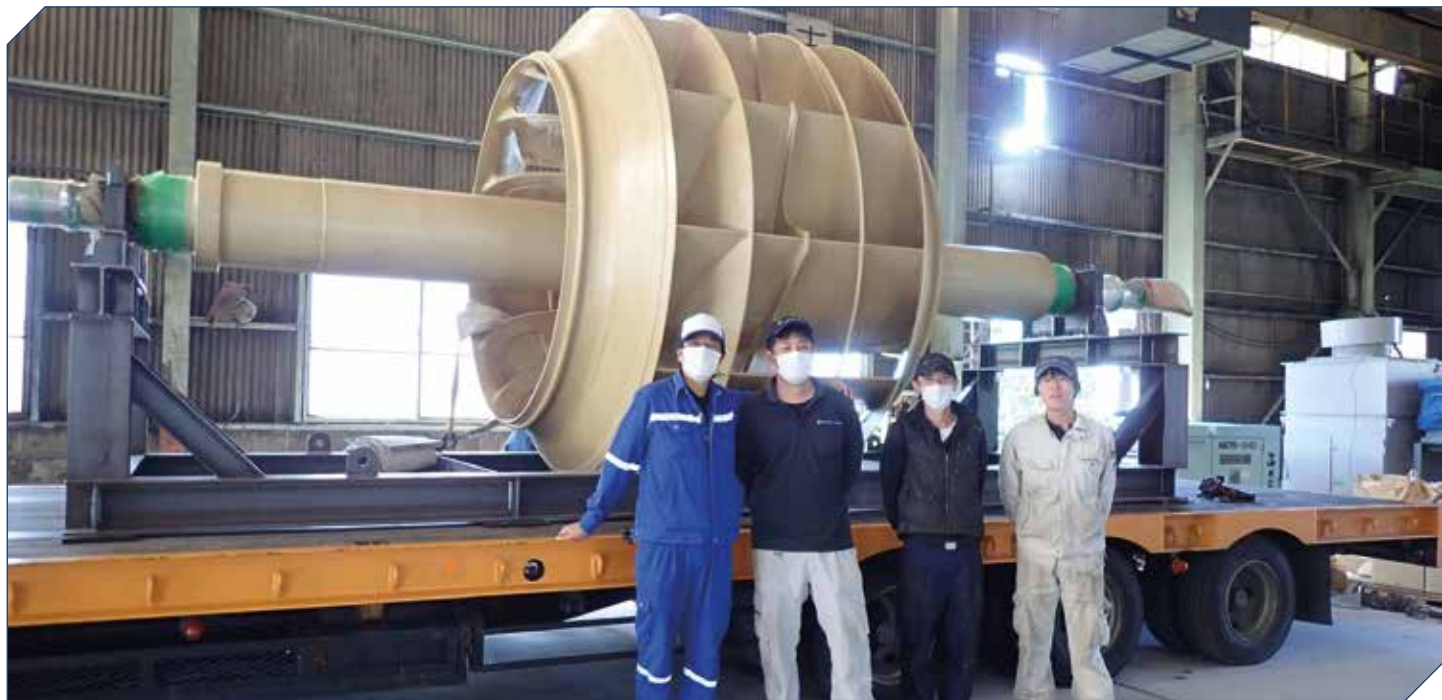
# Corrosion Protection for new large diameter Gas Blower

**Corrocoat Japan recently provided corrosion protection for a newly manufactured gas blower rotor intended for a gas cleaning system at a chemical plant. The impeller and shaft, with an external diameter of 2.57m and a length of 8m, weighed over 3 tons and was destined for installation at a chemical plant aimed at removing toxic gases from various chemical manufacturing processes.**

Due to the size of the blower, the team at Corrocoat Japan took 2 weeks to complete the project on-site. Special facilities were constructed for blasting and the application of Polyglass VE and VE Veilcoat to ensure that the equipment had suitable encapsulation from the surrounding environment.

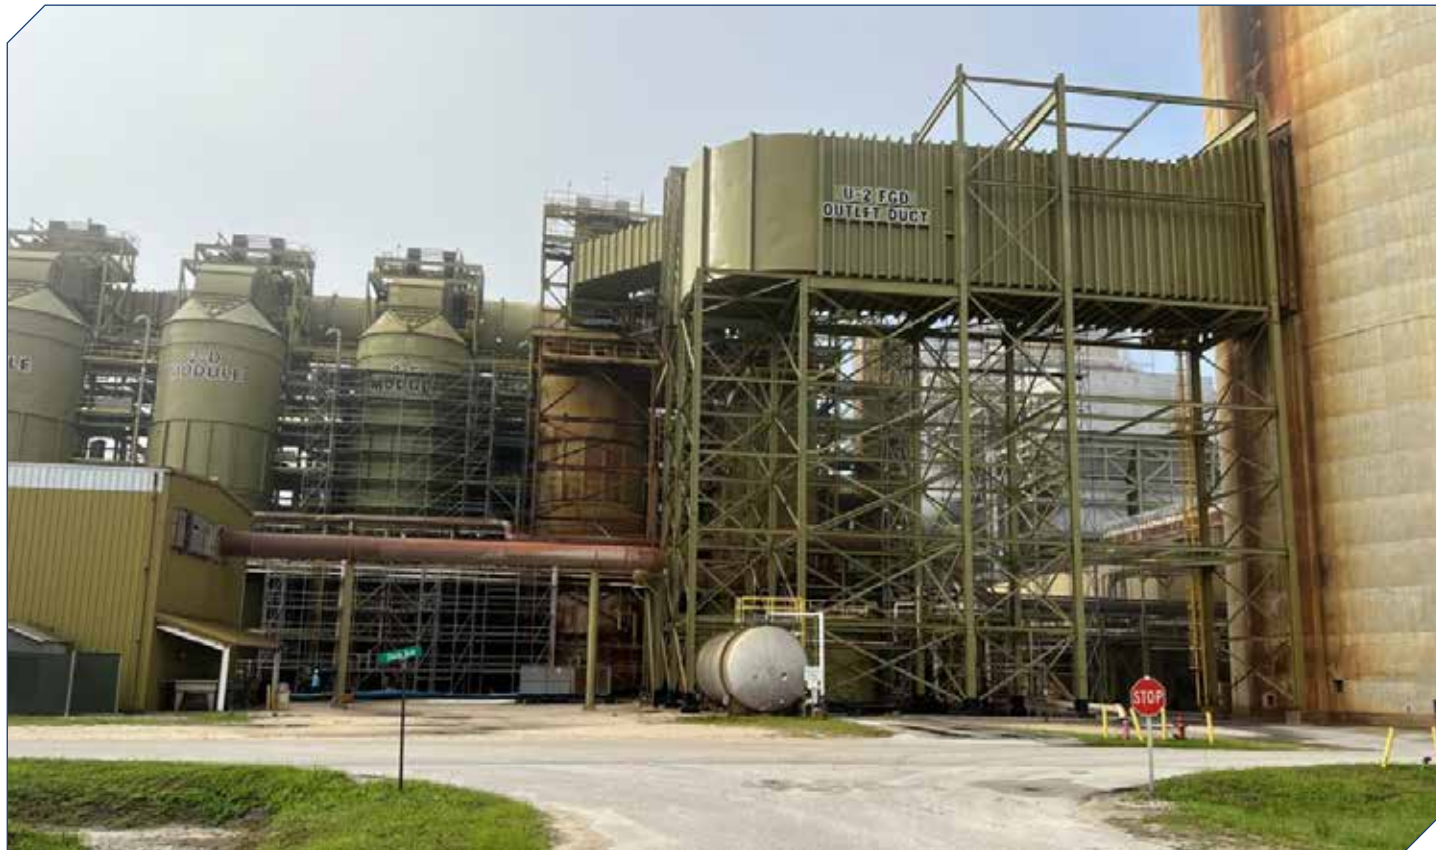
# Relining of Floor Section on Sizeable Outlet Duct

**One of Corrocoat USA's longest-standing clients; a 1.2 Giggawatt coal fired power plant in North Florida, required relining of a large section of the floor of a 35-year-old outlet duct\* with a total surface area of 2,200 ft<sup>2</sup>.**

The outlet duct at the plant was of a considerable size, and sitting 120 feet (36.6 meters) off the ground. The 450 feet (137 meter) long structure graduated from 12.5 feet (3.8 meters) diameter on one end out to 14 feet (4.3 meter) x 25 foot tall (7.6 meter) on the end, feeding into the stack. Corrocoat had 18 consecutive days to complete the project during the plant's 28-day unit outage, coordinating with other contractors and outage related scopes of work, during the short span of time.

After the blasting process, the team removed the grit from the surface to conduct a weld inspection. The blasting uncovered several areas in need of weld repairs. Following the welding repairs, the weld areas underwent re-blasting before the grit was thoroughly cleaned out of the duct. The surface was then primed with a holding primer - Polyglass PPA.

Finally, the surface was laminated with 1.5 oz chopped strand fiberglass mat using Corroglass L600 series, followed by application of Polyglass VEF at 40 mils (1,000 microns) dft. Based on previous experience in this service environment, Corrocoat expects the new liner to last more than 30 years. The team completed the project 2 days ahead of schedule.

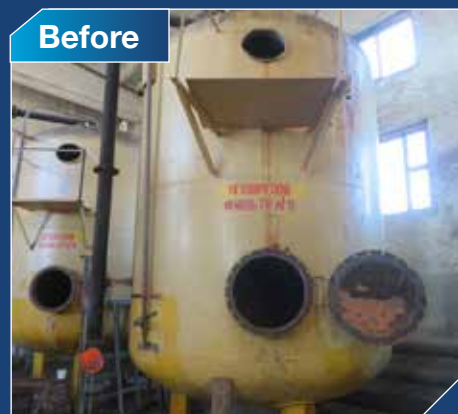
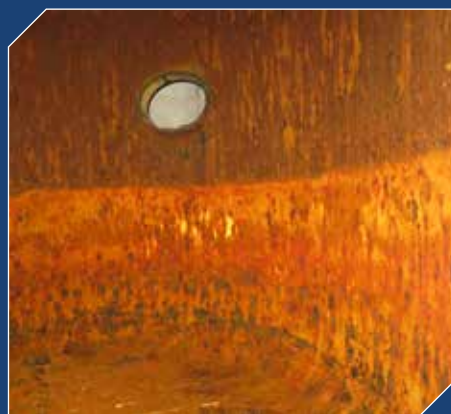
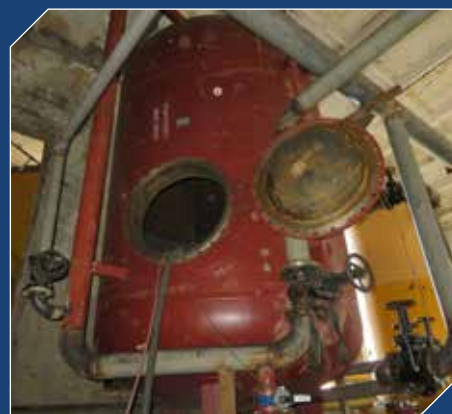
Before

All of the equipment was in poor condition, operating in a service environment with water and various chemicals at temperatures exceeding 50°C. Due to the absence of any corrosion protection over the years, they had heavily corroded equipment, resulting in thinning of the steel. Replacing the old equipment was not a viable option due to time and cost implications.

The Corrocoat Caspian team carried out the repair process on-site at the power station, removing surface contamination and abrasive blasting the surface of the equipment prior to coating application. Corroglass 600

series was applied manually on seams and heavily corroded areas, followed by Polyglass VEF, which was applied via spray application.

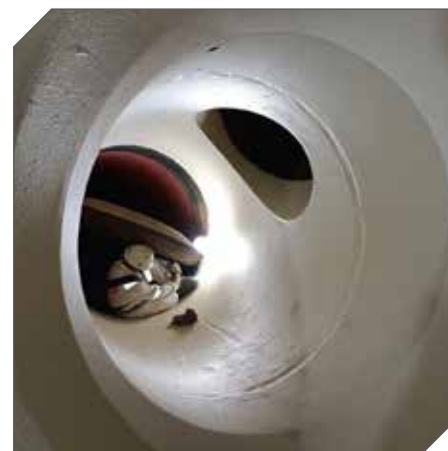
Main condenser scoop pipe for sea water intake

The team got to work replacing the existing rubber lining on a main condenser scoop pipe (Port 1800mm dia x 4100mmL / Stbd 1800mm dia x 10 meter) for sea-water intake and a sea chest strainer (Housing – 1250mm dia x 1500mmH x 2 BR 1000mm dia x 500mmL), with our Polyglass Standard. It took the team 3 full days (including 2 overnight shifts), to complete the work on the pipe, and 3 days for the strainer.

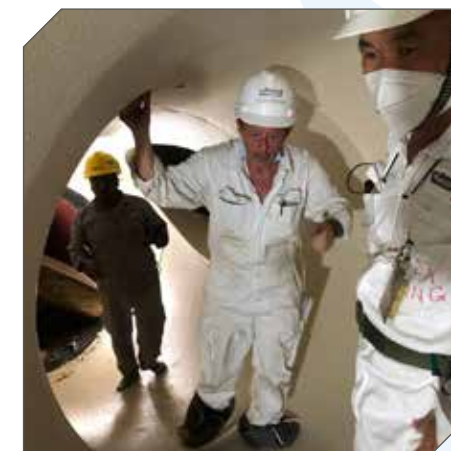
Water was leaking from the condenser tube hole while coating application was applied. The affected coating area needed to be cleaned and allowed to dry before a new layer was reapplied.

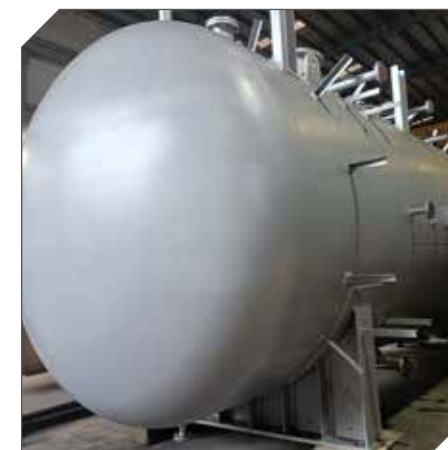
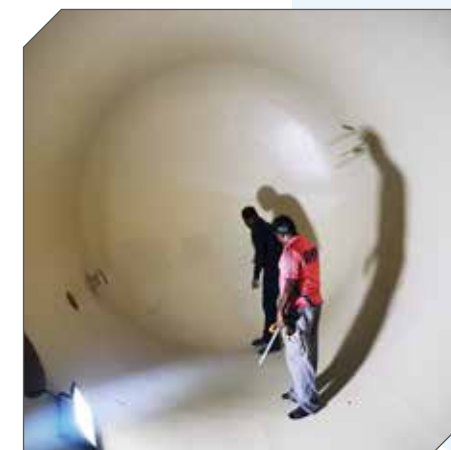
Marine growth preventive system

Another project undertaken, was the mechanical repair and application of a protective coating on a marine growth preventive system (MGPS Housing – 1000mm dia x 1600mm Cover – 1200mm dia) tank. Polyglass Standard was once again the coating system selected, as it performs exceptionally in immersion environments, including marine and aqueous.

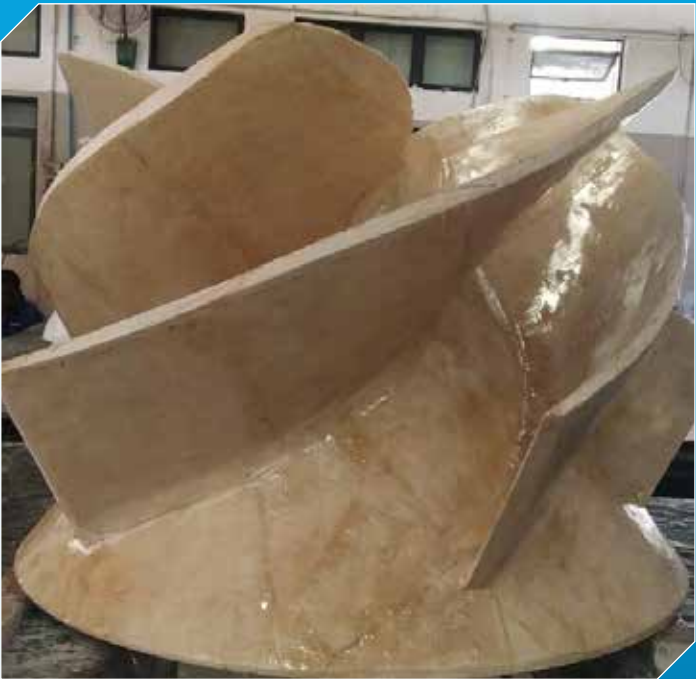
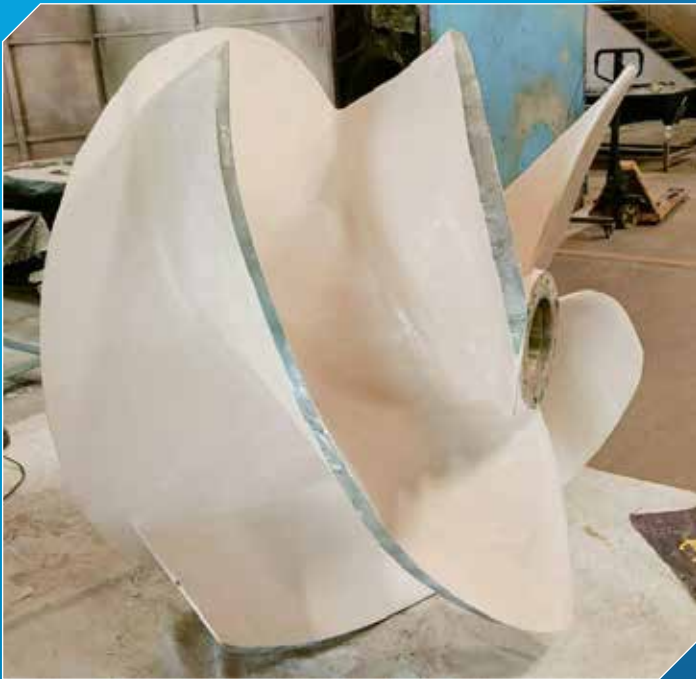
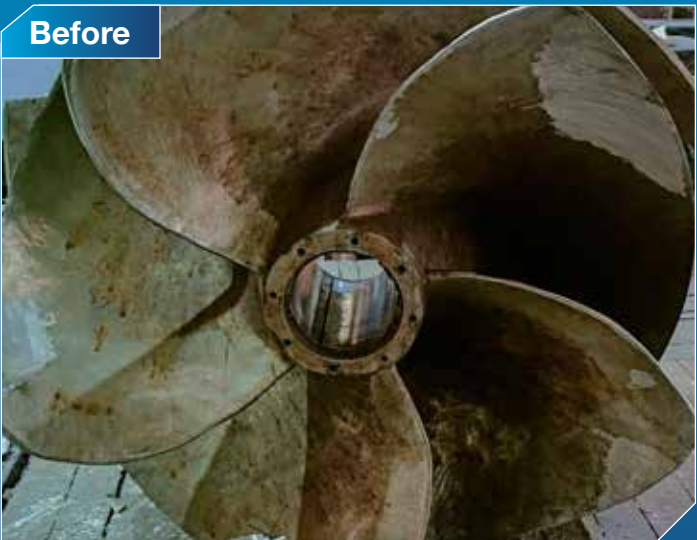
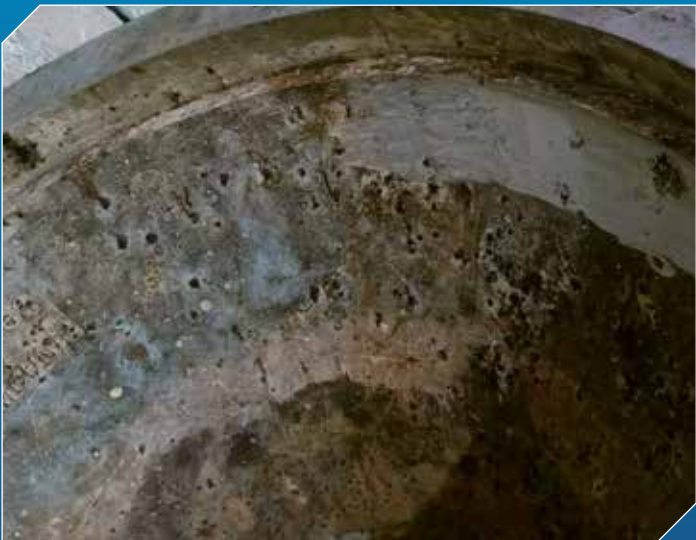
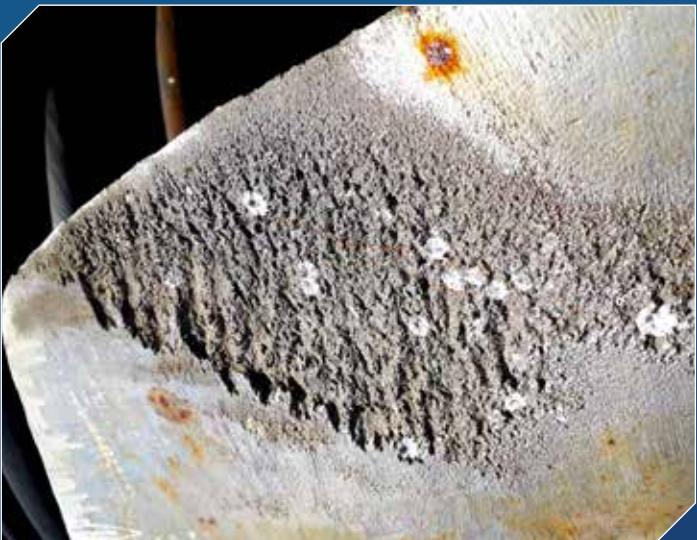
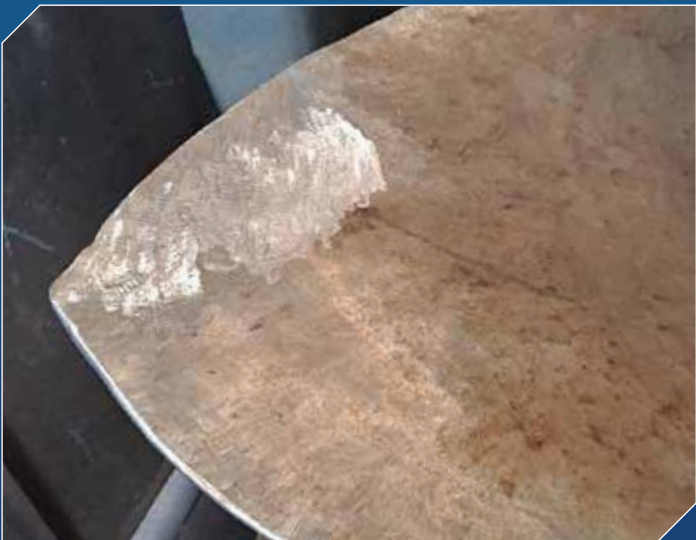
# Refurbishment & Coating of Impeller with Heavy Erosion & Pitting to the Offshore, Marine and Energy Industries.

At this particular plant, seawater serves as the circulating water through vertical turbine pumps, equipped with Super Duplex SS Impellers. Following 12 years in operation, the impellers started to experience heavy pitting, which ultimately lead to performance issues in the pumps. With a proven and reputable

Not only did KCPL's specialised pump refurbishment and coating technology

provide an effective and efficient solution, ensuring an extended lifespan, improved performance and significant cost savings with a very short lead time, they also ensured that the material of construction (MOC) and pump performance remained uncompromised.
